Tire Exception Report

Units Inspected: 6

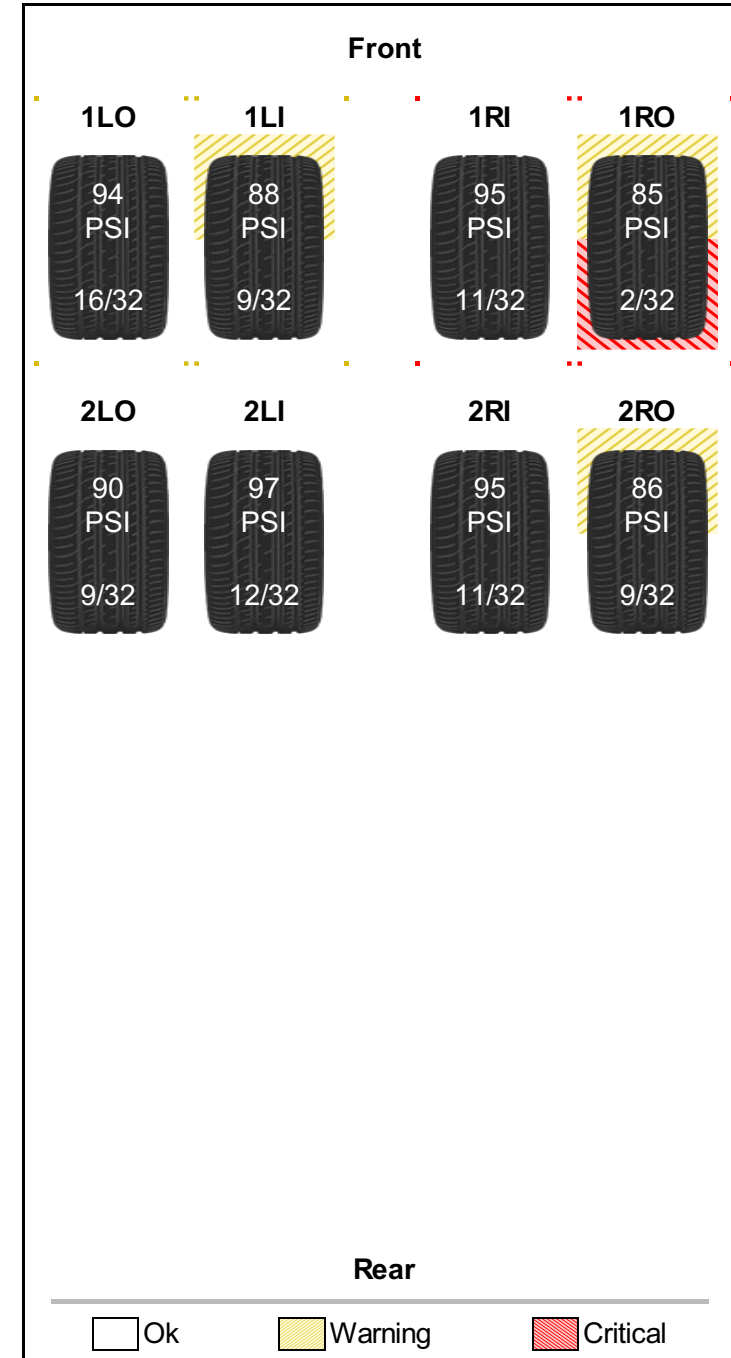
Unit 40312

Position	Conditions	Valve	Brand	Product Line	Size	Load Range	Images	Comments
1LI		Flow Through			295/75R22.5			
2RO	RTD Edge Lifting	Flow Through			295/75R22.5	G	View	tread lifting
1RO		Flow Through			295/75R22.5		View

Position	Condition
1L	Mismatched Dual
1R	Mismatched Dual

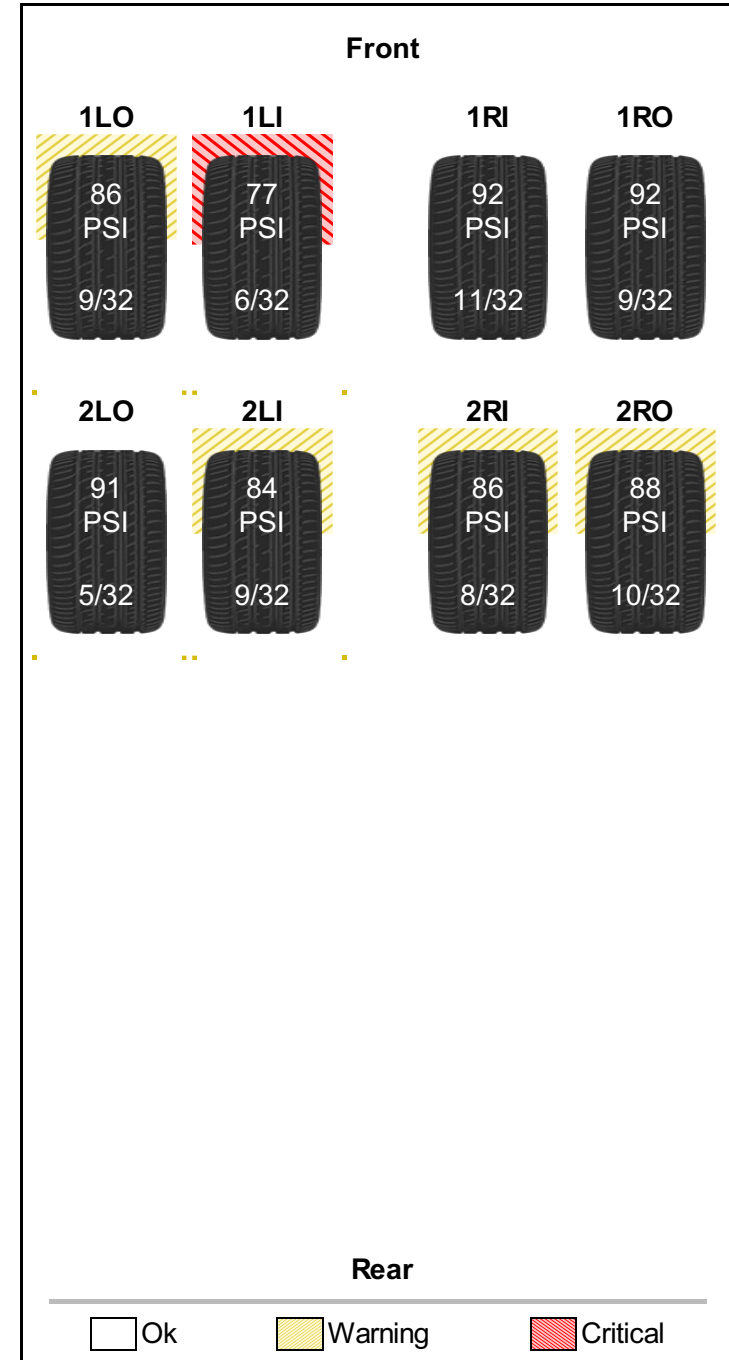
Unit 40310

Position	Conditions	Valve	Brand	Product Line	Size	Load Range	Images	Comments
1LO	Weathering/Ozone Cracking	Flow Through			295/75R22.5		View	
1LI		Missing Cap			295/75R22.5			
2LO	Diagonal Wear	PSI System			295/75R22.5		View	
2LI		PSI System			295/75R22.5			
2RO	RTD Edge Lifting	Flow Through			295/75R22.5		View	
2RI	RTD Edge Lifting	Flow Through			295/75R22.5		View	
1RO	Chipping/Chunking Tread	Flow Through			295/75R22.5		View

Position	Condition
2L	Mismatched Dual

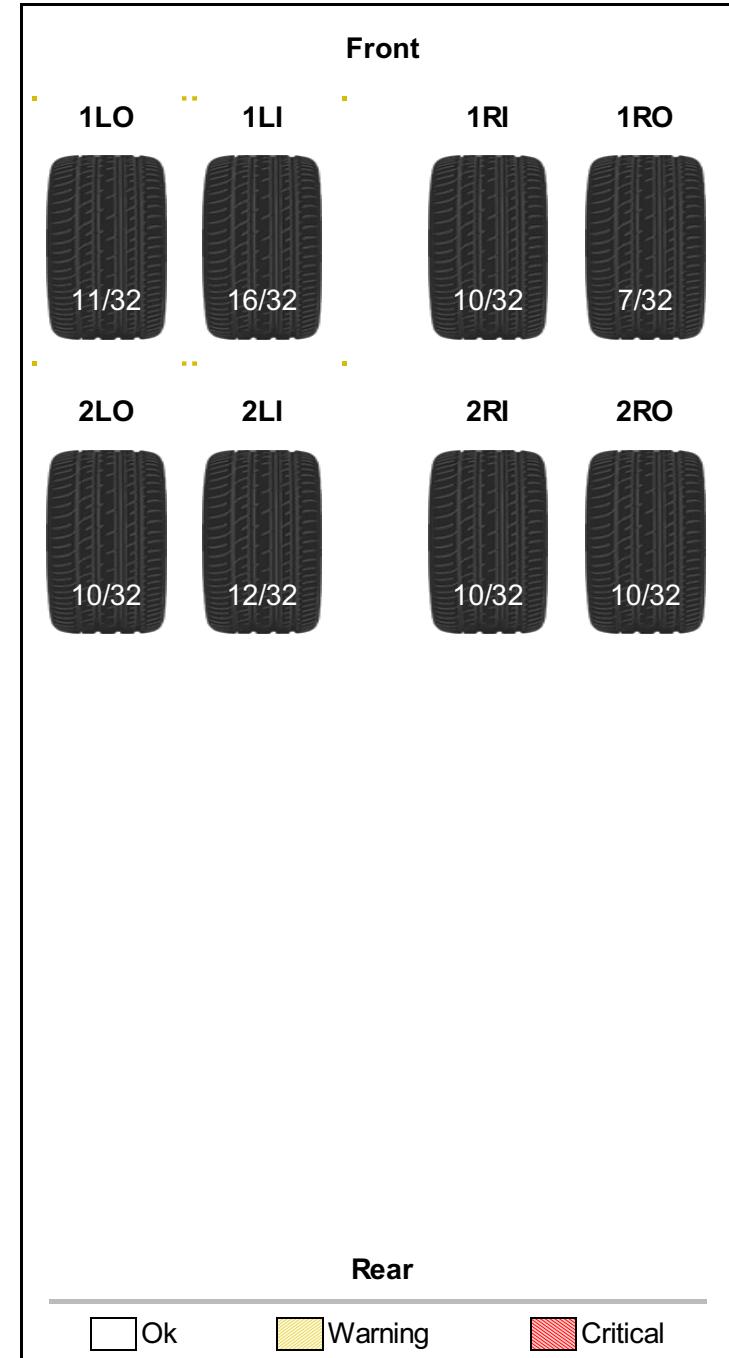
Unit 41972

Position	Condition
1L	Mismatched Dual

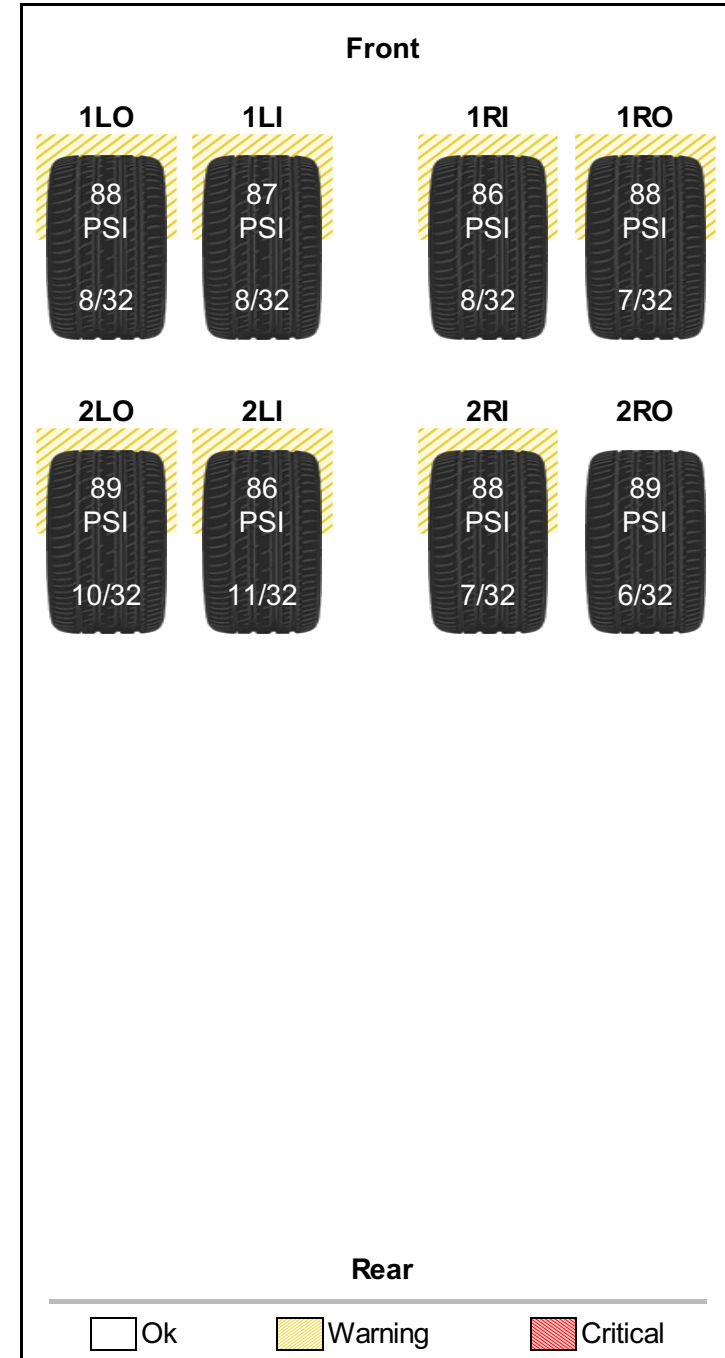
Unit 40080

Position	Conditions	Valve	Brand	Product Line	Size	Load Range	Images	Comments
1LO	RTD Edge Lifting	Flow Through			295/75R22.5		View	
1LI		Flow Through			295/75R22.5		View	nail in tread
2LO		Flow Through			295/75R22.5			
2LI	RTD Edge Lifting	Flow Through			295/75R22.5		View	
2RO		Flow Through			295/75R22.5			
2RI		Flow Through			295/75R22.5			
1RO		Missing Cap			295/75R22.5		View	curb rash, shoulder chipping
1RI		Missing Cap			295/75R22.5

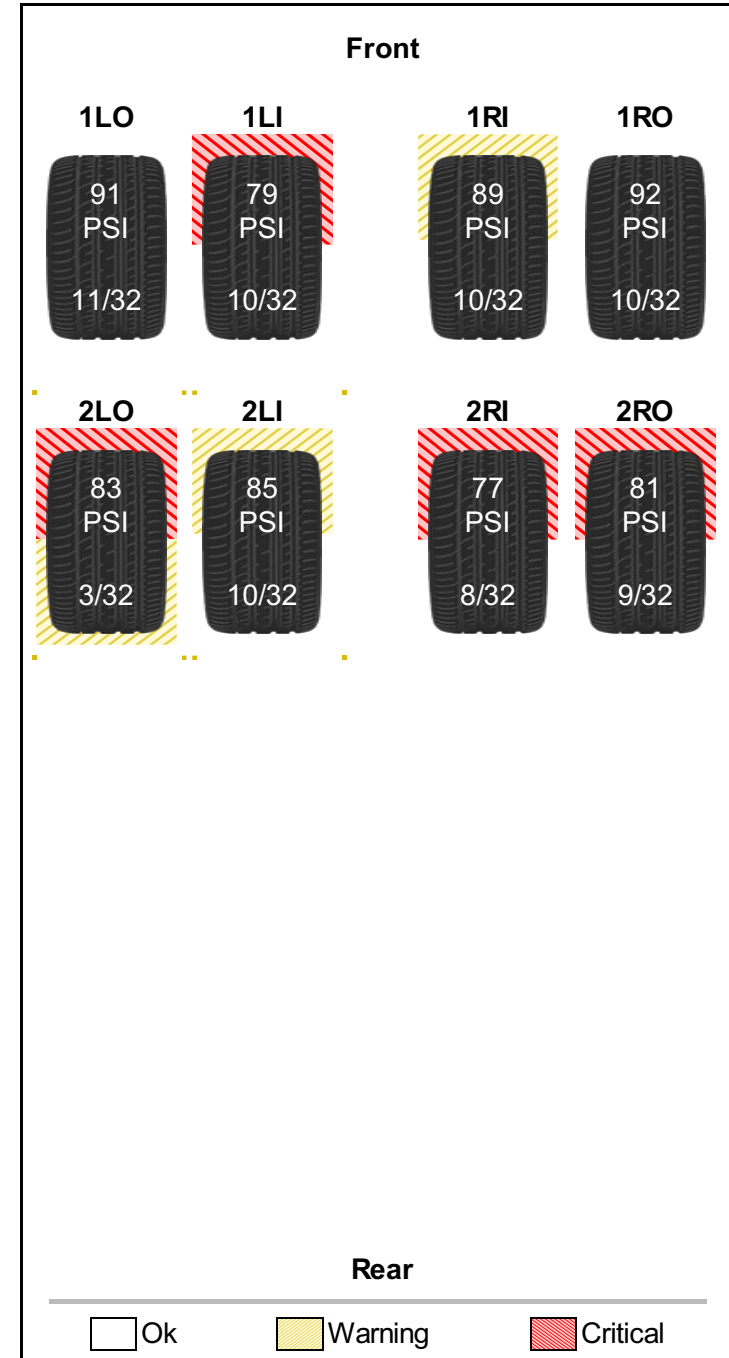
Unit 40313

Position	Conditions	Valve	Brand	Product Line	Size	Load Range	Images	Comments
1LI		Flow Through						
2LO	Diagonal Wear	Flow Through					View	
2LI		Flow Through						
2RO		Flow Through						
2RI		Flow Through						
1RI		Flow Through

Position	Condition
2L	Mismatched Dual

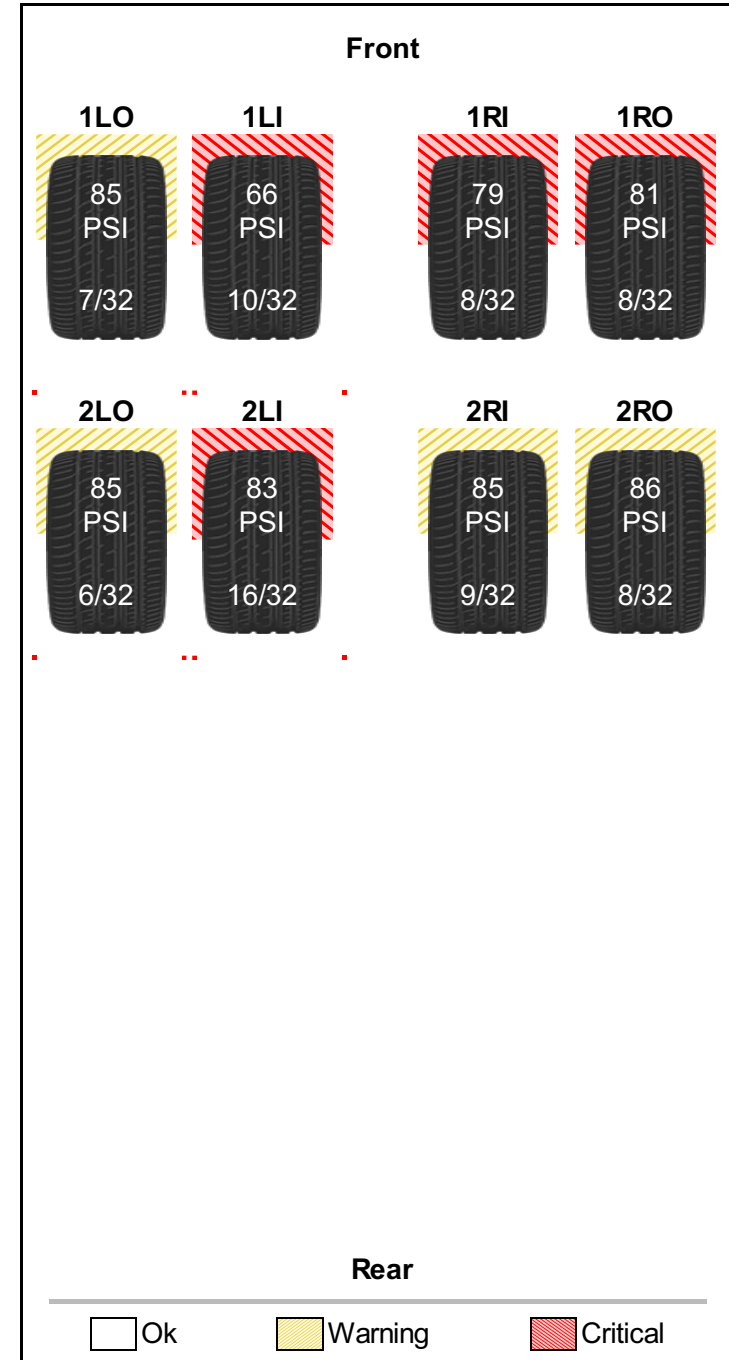
Unit 40328

Position	Conditions	Valve	Brand	Product Line	Size	Load Range	Images	Comments
1LO	RTD Edge Lifting				295/75R22.5		View	
1LI					295/75R22.5			
2LO					295/75R22.5			
2LI					295/75R22.5			
2RO					295/75R22.5			
2RI					295/75R22.5			
1RO					295/75R22.5			
1RI					295/75R22.5

Position	Condition
2L	Mismatched Dual
